NASA TN D-7588

EFFECTS OF LOW-PRESSURE AIR
ON OXYGEN CONTAMINATION
AND LITHIUM CORROSION OF
A TANTALUM ALLOY, T-111,
AT 980° AND 1260° C

Lewis Research Center
Cleveland, Ohio 44135

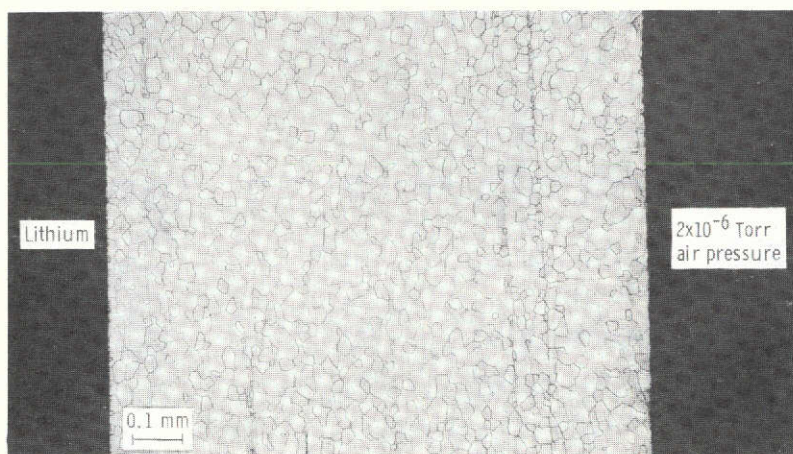
Figure 6. - T-111 isothermally tested at 980°C and 2×10^{-6} torr for 96 hours. Specimen etched. X100.

The wall cross section from capsules tested at 2×10^{-6} (fig. 6), 5×10^{-7} (fig. 7), and 1×10^{-8} torr (fig. 8) and 980° C were similar. These specimens showed the longitudinal streaks of unidentified grain boundary precipitate which are typical of T-111 aged at 980° C. Hardness profiles shown in figure 13 indicate no change in hardness from the outside to the inside of the 5×10^{-7} - and 1×10^{-8} -torr specimens. The hardness of the 2×10^{-6} -torr specimen was greatest at the outside surface and leveled off at a depth of about 0.25 millimeter.

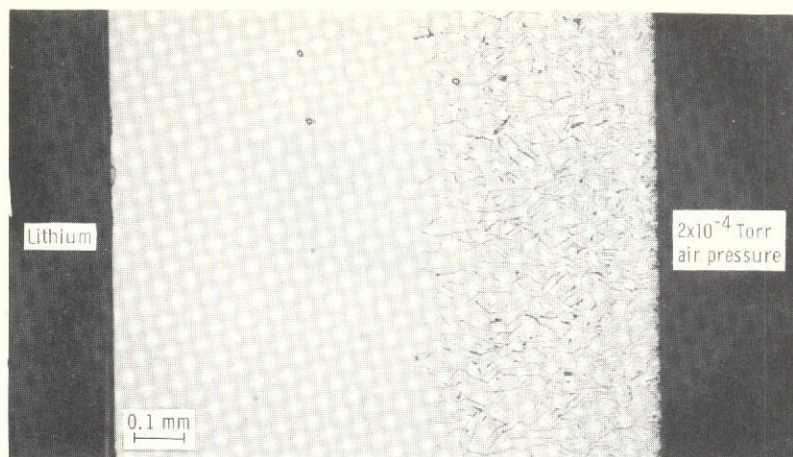
(a) Wall.

(b) Weld.

Figure 9. - T-111 cyclically tested at 1260° C and 2×10^{-4} torr for 96 hours. Specimen etched, X100.

All capsules tested at 1260° C completed the 96-hour exposures at the various pressures. Observation by optical microscopy of etched wall specimens from the capsule tested at 2×10^{-4} torr (fig. 9(a)) indicated the presence of two different structural regions across the wall. At the outer wall, both inter- and intragranular oxidation are evident. Oxidation at the outer surface occurred to a depth of about 0.4 to 0.5 millimeter on both isothermal and cycled T-111. Hardness measurements (fig. 14) also indicated a sudden change at this distance. Hardness in this instance increased from the outside to the inside. After polished specimens stood in air, the moisture trapped in the porous phase stained the surface, giving it an etched appearance. The inner portion of the capsule wall was difficult to etch, similar to the inner portion from the capsule tested at 980° C and 3×10^{-4} torr (fig. 4(a)). The high hardness and etching difficulty are attributed to saturation of the matrix with oxygen. An optical photomicrograph of the weld area is shown in figure 9(b). The weld also was oxidized intergranularly and appears to be near failure. The dark portion is the capsule lip. This area was surrounded by lithium and apparently consists of a heavy HfO_2 precipitate in a tantalum-tungsten matrix which is not saturated with oxygen.

Electron microscope examination across the wall confirmed the two types of microstructure observed by optical microscopy. Two-thirds of the inner wall (~0.6 mm) contained uniformly equiaxed grains. The remaining one-third (~0.4 mm) of the wall had fissures running perpendicular to the outer wall. Precipitates were observed, but only in the portion having the equiaxed grains. These precipitates were identified by X-ray diffraction as HfO_2 .

The potential for failure of T-111/lithium systems by internal oxidation in poor vacua appears greater than the potential for failure by lithium corrosion. Metallography reveals that oxidation occurs in three stages, as can be seen in the micrographs of the capsule walls after exposure at 2×10^{-4} to 3×10^{-4} torr (figs. 4 and 9). The first

stage is oxidation of hafnium to HfO_2 , which occurs to a considerably greater extent at 1260°C than at 980°C . The second stage is saturation of the tantalum-tungsten matrix with oxygen to form the hard, unetched zone visible after exposure to air pressures of 2×10^{-5} torr or higher. The third stage consists of actual intergranular oxidation and the formation of intragranular oxide platelets on preferred planes of the matrix. Areas containing those porous oxides are difficult to prepare metallographically because they easily stain. These areas are visible on the specimens exposed at 2×10^{-4} to 3×10^{-4} torr (figs. 4 and 9). The weakness of these regions is evident in figure 4, where a number of grains fell out during specimen preparation. Failure of the two capsules at 980°C and 2×10^{-4} to 3×10^{-4} torr is attributed to the weakness of these intergranularly oxidized regions in the thin areas of the welds.

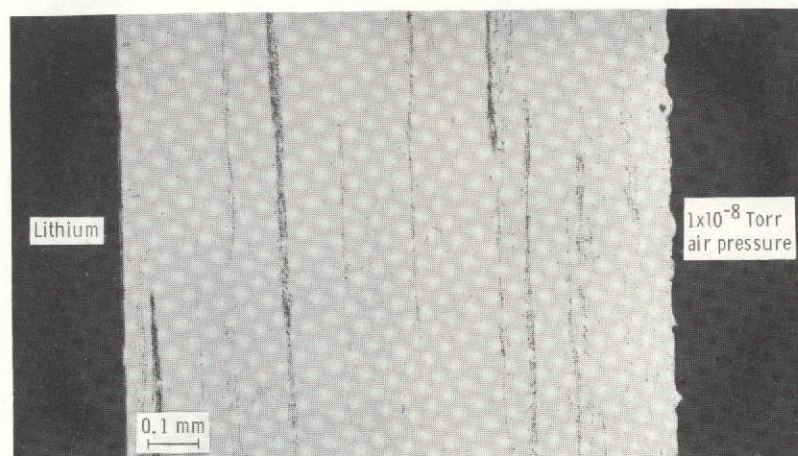
Figure 12. - T-111 isothermally tested at 1260⁰ C and 1x10⁻⁸ torr for 96 hours, Specimen etched. X100.

At 2×10^{-6} (fig. 11), 5×10^{-7} , and 1×10^{-8} (fig. 12) torr and at both 980° and 1260° C, there appear to be no significant differences in the metallography of the T-111. Both materials exhibit the typical grain boundary precipitation observed in T-111 aged at these temperatures.
